4. TITLE (and Subtitle) National Program of Inspection of Non-Federal Dams, Tennessee. Colonial Country Club-16th Hole Dam (Inventory Number TN 15774) near Memphis, Tennessee, Shelby County, TN. Wolf River Basin		5. TYPE OF REPORT & PERIOD COVERED Phase I Investigation Report

PHASE I INSPECTION  
COLONIAL COUNTRY CLUB 16th HOLE DAM  
SHELBY COUNTY, TENNESSEE

PHASE I INSPECTION REPORT  
NATIONAL DAM SAFETY PROGRAM  
TENNESSEE

Name of Dam Colonial Country Club - 16th Hole  
County Shelby  
Stream Tributary Fletcher Creek  
Date of Inspection April 2, 1981

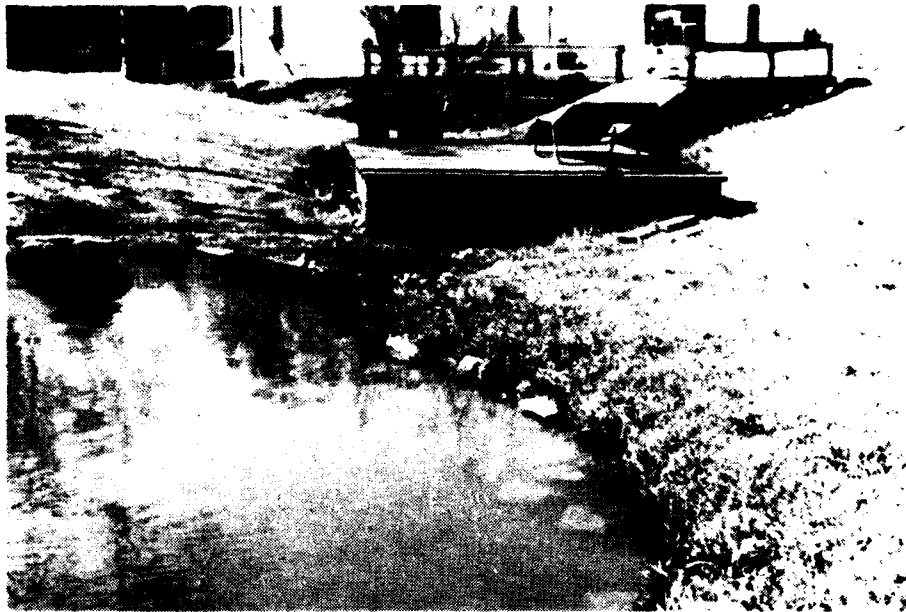
- b. There is no effective means to draw down the lake for maintenance or in case of an emergency.
- c. The Colonial Country Club - 16th Hole Dam poses a high hazard potential to the downstream development. The original dam was built as a farm pond approximately 50 years ago. The dam appears to have been altered for the subdivision development and the type of alterations is unknown. The present location of the spillway with earth waterway through the backyards poses considerable hazard for the homes located along this waterway in the event of a major storm.

5. Control section of emergency spillway and service spillway for Colonial Country Club - 16th Hole Dam. Note location of house.

At this time, the dam is considered "deficient". It is recommend that a qualified engineer be engaged to: determine the feasibility of relocating the emergency spillway so that the house sites that presently adjoin this facility would be protected; recommend a plan for the removal of undesirable brush and trees from the side slopes; recommend repairs to the telephone cable trench on the downstream slope; and develop an emergency action plan to alert downstream residents in the event a major problem develops with the dam.

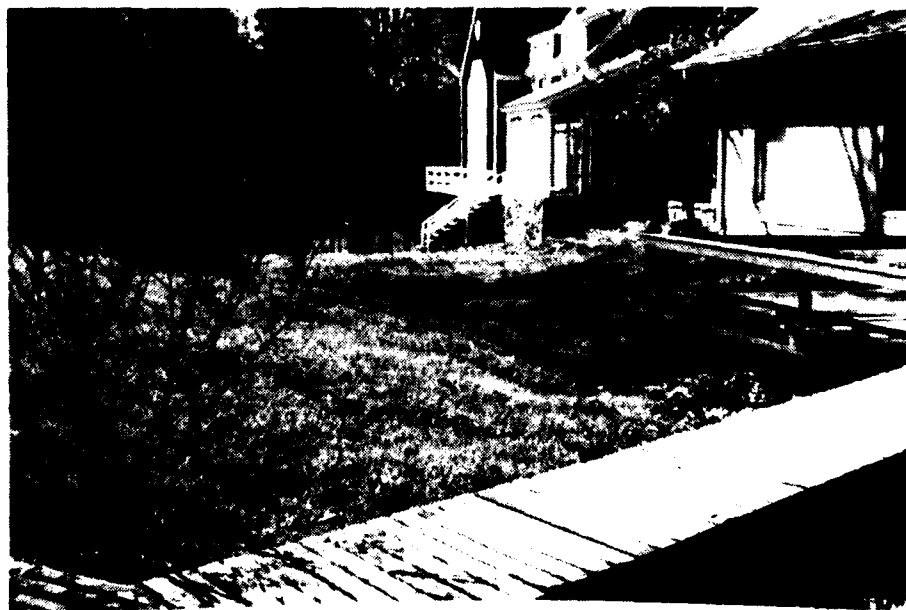
6. Outfall swale for emergency spillway approximately 50 feet from control section.

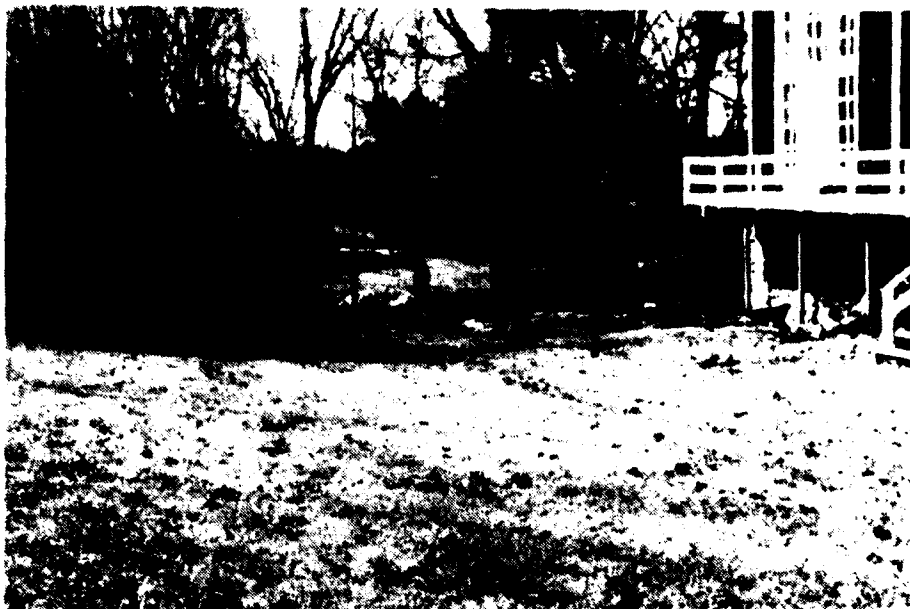
7. Outfall swale for emergency spillway immediately downstream from Photo No. 6.
